Employees Injured During Train Collision on Napier Subdivision

SB-2021-10T
Dec. 8, 2021

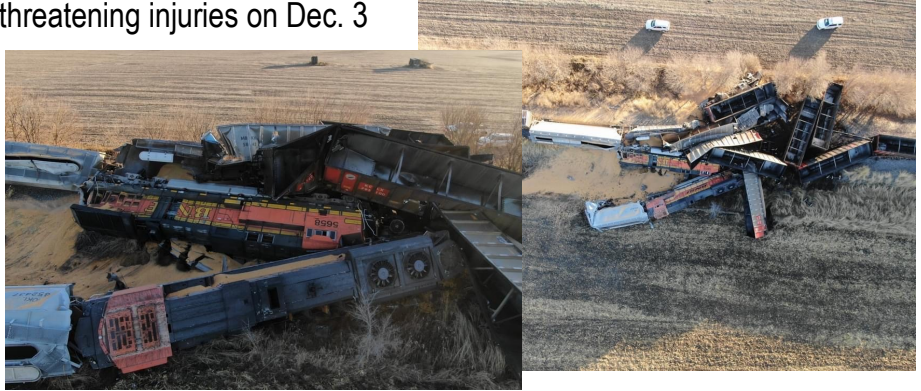
Two BNSF employees sustained non-life threatening injuries on Dec. 3 after a rear-end collision occurred between an empty coal train and a manifest train on the Napier Subdivision of the Heartland Division.

We are extremely thankful that this incident did not result in a tragic loss of life. It did, however, result in a large-scale mainline derailment.

At approximately 6:32 a.m. Central Standard Time (CST), an empty coal train operating North-bound on the Napier Subdivision at approximately 42 MPH impacted the rear end of a manifest train that was stopped at Pacific Junction. This incident occurred outside the track warrant limits of the empty coal train, resulting in non-life threatening injuries to two crew members and the derailment of a total of 16 cars and two locomotives (combined from both trains).

Alert and Attentive: As professional railroaders, it is vital to avoid **distractions, complacency** and **rushing**. We must take ownership through our ability to make safe decisions in every task performed and hold ourselves and others accountable. Let's all continue to identify the risks, pause the work, re-brief and make appropriate adjustments in order to keep everyone safe.

Communication is Key: Clear communication is crucial to safety. Never make assumptions — ask for clarification if you are in doubt about what was said or heard during transmission and repetition of track authorities.

Track Warrant Limits: It is critical that crew members understand, copy and repeat their track warrant back to the Dispatcher correctly each time or follow SSI 18 Electronic Delivery of Information and refer to the track warrant form, as needed, to ensure their train does not exceed their authority limits or the train crew doesn't roll up the limits of authority that are still being occupied by another train crew. When using the Electronic Delivery of Information method, train crews will receive "delivery prompts" for track warrants. Because PTC is in a disengaged state, these will not be enforced by PTC. The train dispatcher will state the track warrant number, and if included, Box 5 (after arrival). Train crew will confirm receipt of the track warrant to the train dispatcher by stating the track warrant number, limits (including track), and total number of boxes marked—including which specific boxes are marked. The train dispatcher will confirm information repeated is correct.
